## COUNCIL REPORT

M&C No.	2019 - 24
Report Date	February 06, 2019
Meeting Date	February 11, 2019
Service Area	Saint John Water

***SUBJECT: West Saint John – Corrosion Control Investigation***

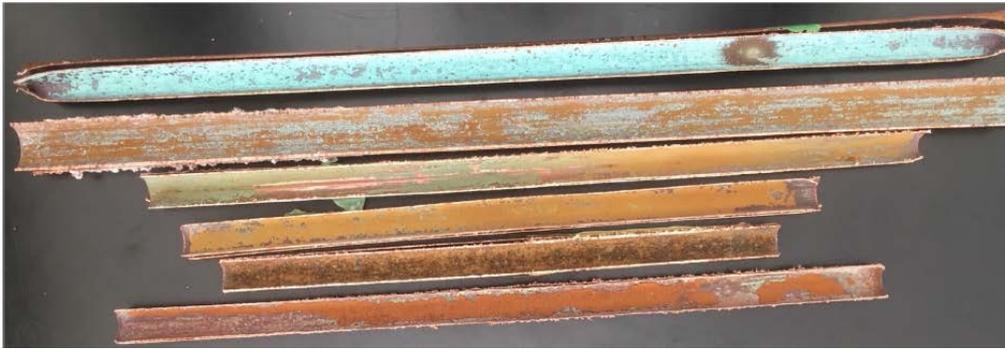
As stated in the CBCL report *"The initial analysis found that the scaling present was largely amorphous (does not have a distinct, identifiable crystalline structure) with some cuprite and malachite present (common copper scale materials), but not well defined. As such, the analyzed scale did not match copper scaling composition that is typically cited in literature. Amorphous corrosion scales commonly occur on copper piping; however as the composition of the scaling can vary greatly between systems, there is little research completed on amorphous scaling and copper solubility."* Figure 1 below shows examples of copper plumbing corrosion.

Figure 1. Sections of Copper Pipe cut longitudinally for scale analyses

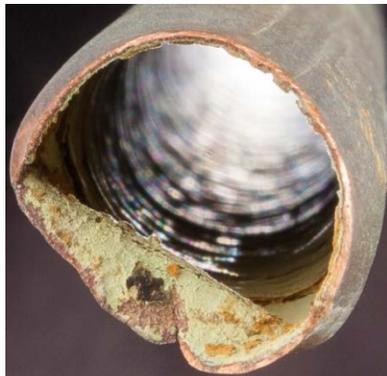
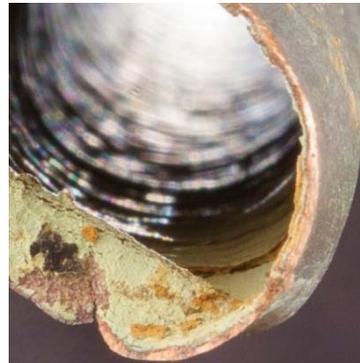
*structural pipe integrity. When the water supply transitioned to the higher pH, higher alkalinity water, it is likely that a transient event occurred where the existing scale was disrupted before a new, passivating scale (based on the changed water quality) could be formed. As the existing scale was disrupted, the corroded pipe in the system was exposed and leaks began to occur. This is different than the deterioration of pipe material due to new corrosion. Transient events can vary in length from hours to months and it appears that the one experienced in West Saint John occurred over several months. Such occurrences are not well documented elsewhere and not anticipated from existing corrosion models.”*

Figure 2. West Saint John Copper Pipe

Figure 3. West Saint John Copper Pipe Close-up

This result aligns with the theoretical understanding communicated in January and February 2018 when some customers were reporting leaking copper pipes. See Figures 2 and 3 for a visual example of the scale existing on a copper pipe that came out of a West Saint John home.

The study showed that the addition of orthophosphate was beneficial for reducing copper release from both mature and new pipe from West Saint John and CBCL recommends that orthophosphate addition continue until additional testing is completed and sufficient evidence is available which can prove a reduction in orthophosphate would not introduce corrosion issues or leaks.

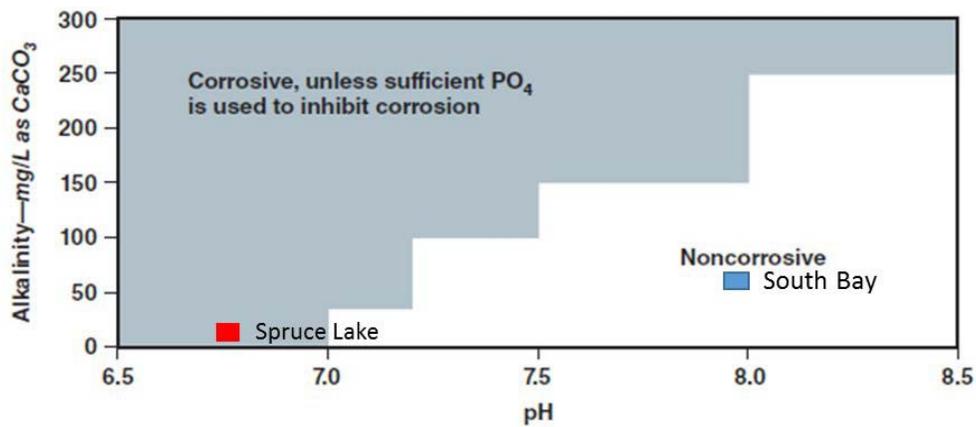
CBCL reported that “From a water quality standpoint, the source water switch from Spruce Lake to the South Bay Wellfield is considered low risk as the water quality was changing from a corrosive water to one that was less corrosive. Significant sampling was completed both at the wells and in the distribution system prior to the switch, however with regards to corrosion within the distribution system, the study was not as intensive as that for a system deemed a higher risk. See Figure 4 below (Figure 3-1 in the CBCL report) as the figure provides guidance as to when orthophosphate addition is required. As shown in the points plotted within the figure, South Bay is deemed to be noncorrosive and Spruce Lake is deemed to be corrosive.

Figure 4. (Figure 3-1 from CBCL report) Conditions that are Corrosive to Copper as Defined by the Lead and Copper Rule Working Group of the National Drinking Water Advisory Committee

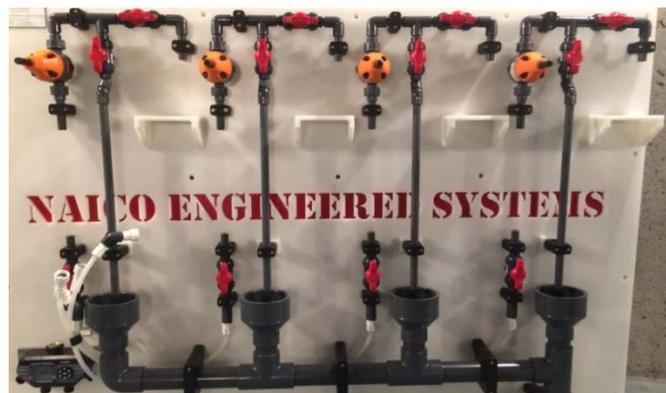
As a result of the reported leaks that occurred, the City developed a monitoring program for the distribution system and it will continue to evolve as more information is collected. The City is incorporating pipe racks as shown in Figure 4 below in several locations within the water distribution system, which contain sections of copper pipe. These sections of copper pipe can be representative of copper premise plumbing within the system. The pipe racks will allow the city to collect information relating to the ongoing monitoring of the effects of orthophosphate addition on premise plumbing.

Figure 5. One of the new pipe racks being incorporated into the Saint John water systems
